## The “Ghostbusters” issue

## The “I/O glitch”

## The cause of the I/O glitch

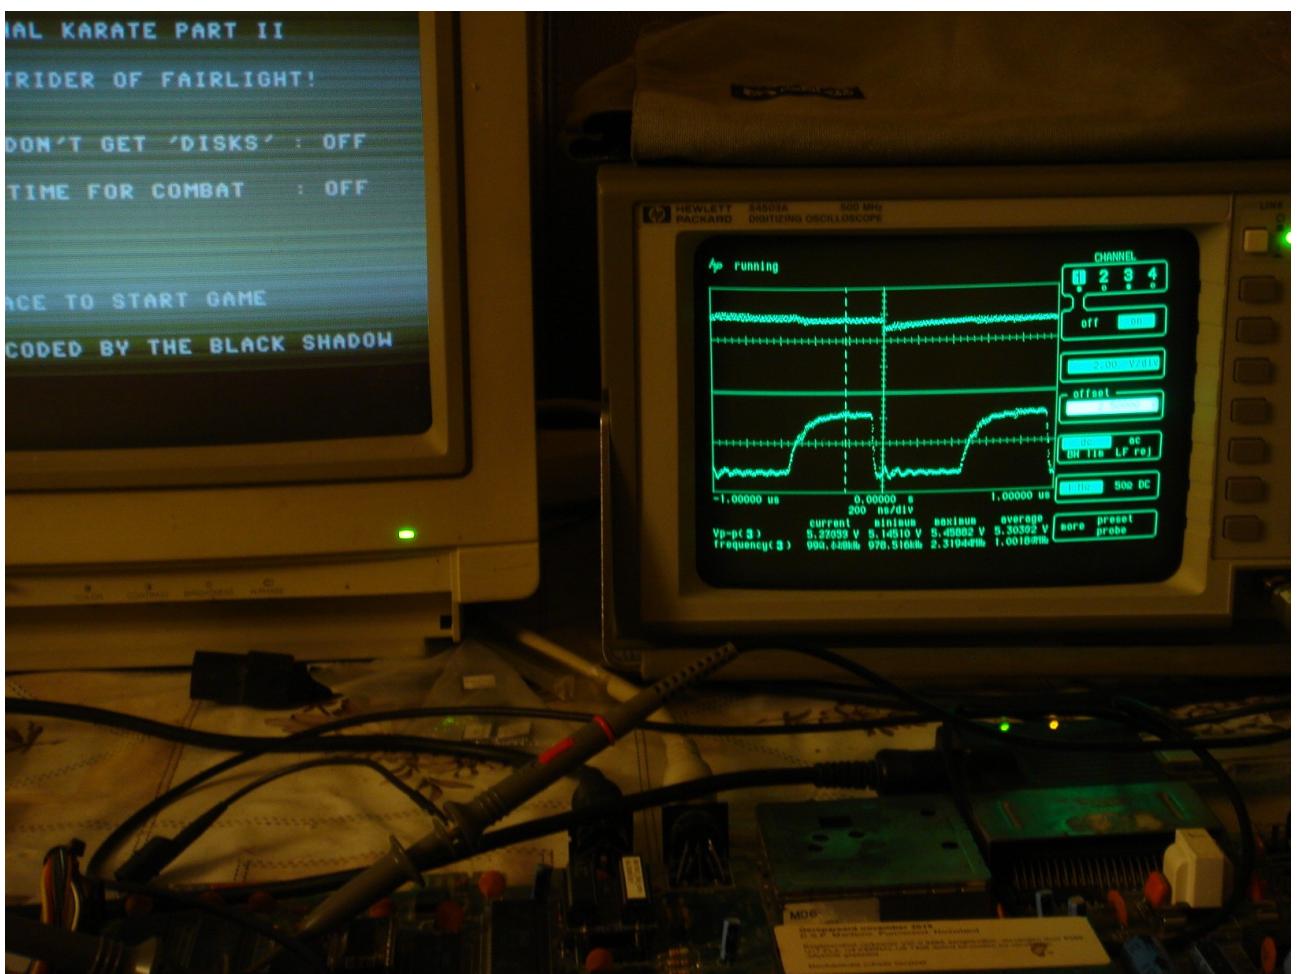
When measuring the chip select of the I/O chips of the Commodore 64, sometimes a small trench appears on the oscilloscope. For example I am starting the Fairlight release of International Karate + (<https://csdb.dk/release/?id=22533>) and when on the trainer selection screen I am measuring the CS line of the SID chip on the top channel and PHI2 on the bottom channel of my oscilloscope:

No music is playing here, so the SID chip should not get selected. In the above example I was using an Assy 250407 with a PLA20V8 with 25ns GALs and the “base” file installed. The oscilloscope was set to trigger on the upper channel at a trigger level of 3.75V.

I call this phenomenon the “I/O glitch”. The I/O glitch is not something specific to the PLA20V8, the original Commodore 906114 shows exactly the same behaviour.

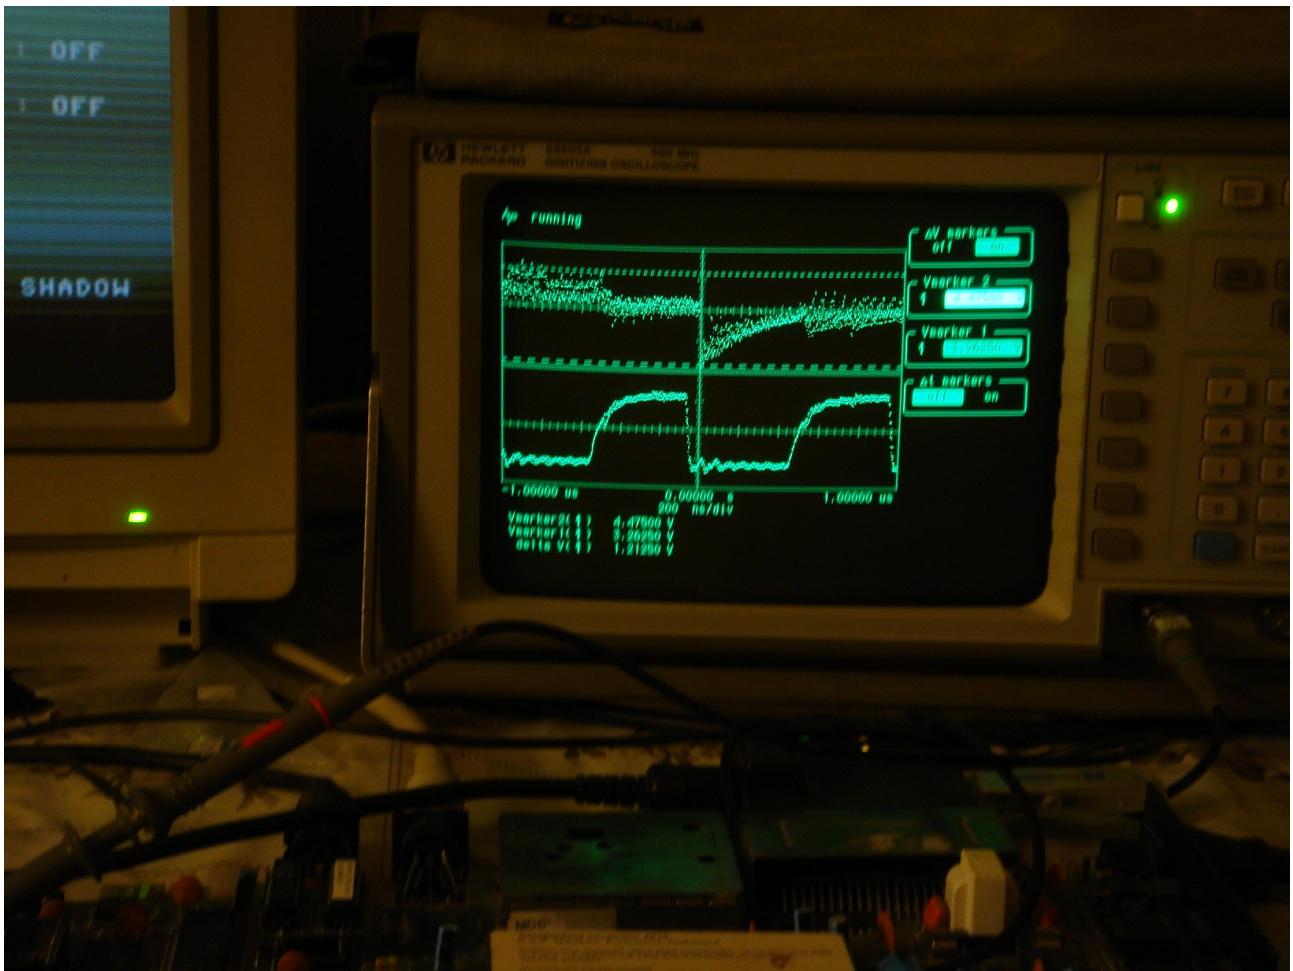
I have placed a marker line at the deepest point of the trench. This is line at 3.26 volt. 3.26 volt is well above the minimum “TTL high” level of 2.0 volt, therefore the trench is harmless and will not trigger any chip.

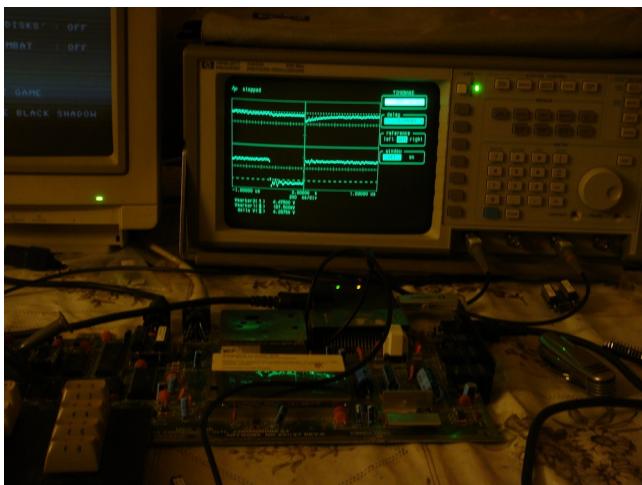
In the following photo I am showing the I/O glitch again on the SID CS line at the top channel, and at the bottom channel the I/O output of the PLA. This reveals the cause of the I/O glitch:

The I/O line was active and this activation ends when the VIC-II uses the AEC signal to take control of the bus. The CPU responds to the chip by releasing the bus and the PLA responds to this by deselecting I/O line.

The 74LS139 on the C64 mainboard is has an enable pin which is connected to the PLA I/O line. This means that when the I/O line becomes deselected, the 74LS139 disables any CS signal to an I/O chip. However, when AEC happens, a lot happens on the bus, i.e. the address bus is transitioning. Transitioning address lines just before the I/O line gets deselected are the cause of the I/O glitch.

Because the I/O glitch exists in the original Commodore 64 PLA and such glitches can be considered undesired, the I/O glitch can be considered a flaw in the logic of the Commodore 64 PLA. It is not difficult to fix the I/O glitch. By using the CAS signal to clock the I/O chip select, it is possible to prevent that the I/O line is active when the AEC signal switches.

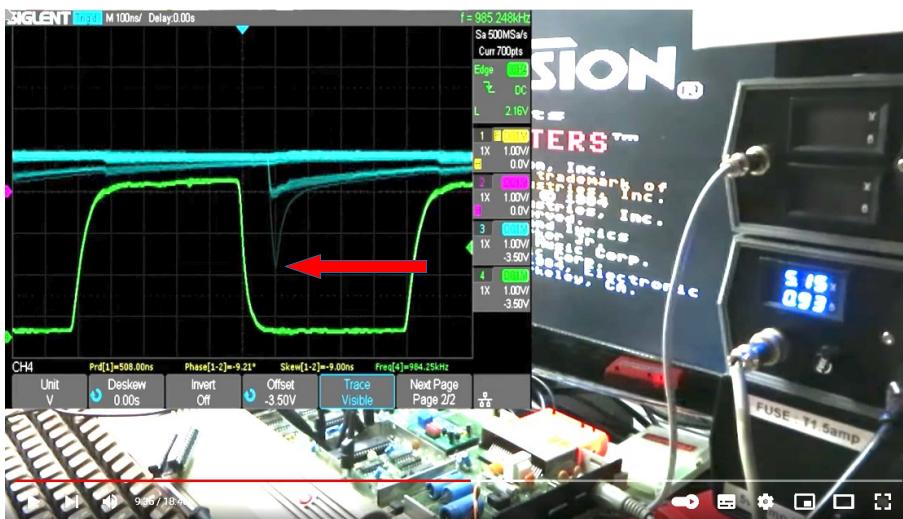
Lee Ashmore's C64 is sensitive to the Ghostbusters issue. Very interesting is that his machine is showing a much deeper I/O glitch trench. This was measured with the original Commodore PLA:

His machine was showing the intro screen of Ghostbusters. I don't know what the deepest voltage of this trench is, but it is clear it won't need to go a lot deeper in order to trigger a TTL low. So if the PLA20V8 just goes slightly deeper (I didn't see it happen in the video), it actually could trigger a chip. This deeper trench is already interesting, but what is even more remarkable is that on my machine, on the same screen, I am unable to see any I/O glitch at all:

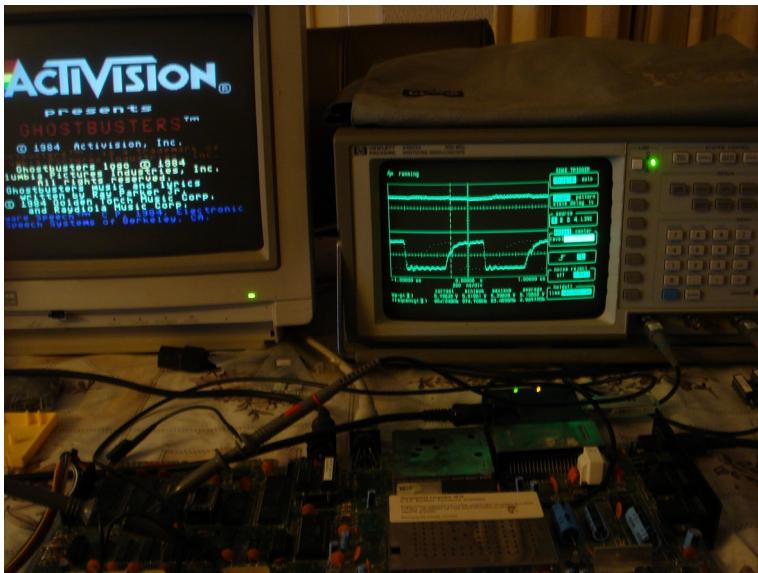
The trigger level of the oscilloscope is set to 3.75V and it keeps waiting indefinitely for a trigger. Only when increasing to 4V it does trigger, but then just shows the stable high logic level:

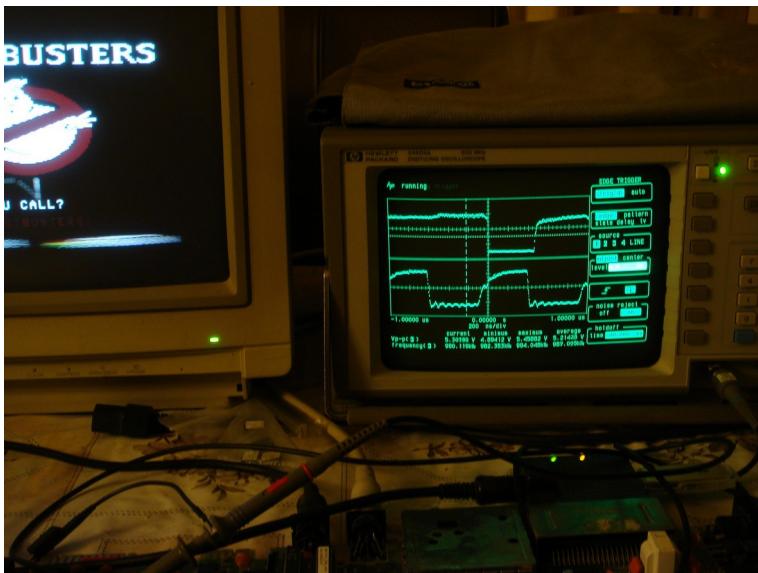
For information, this is how it looks when the game has started and the music is playing (trigger at the normal 1.5V for TTL signals):

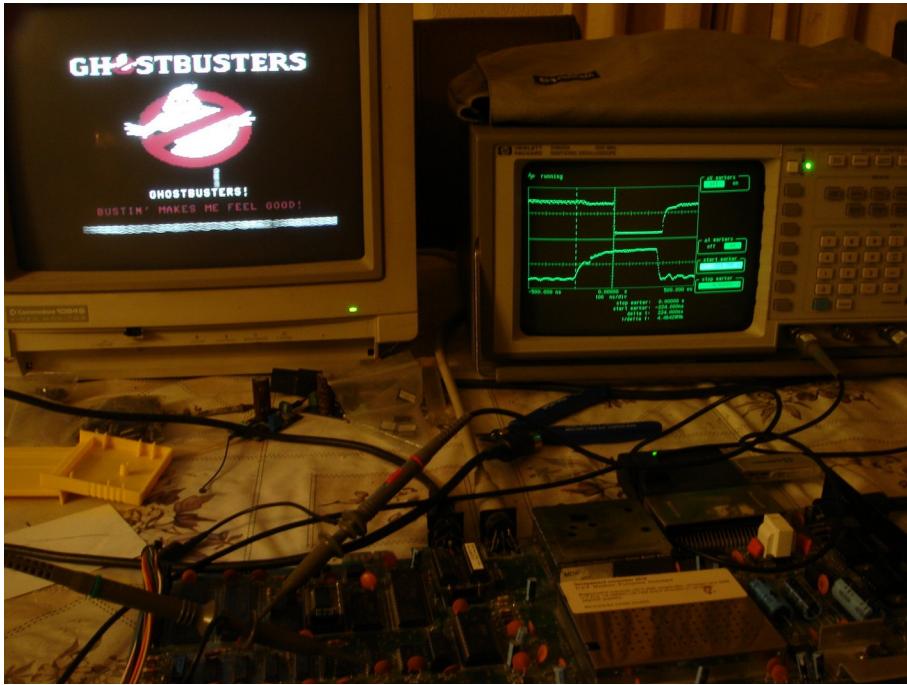
The following photo is taken with a PLA20V8 with such a fix. The result is that the SID I/O line is activated slightly later during the cycle:

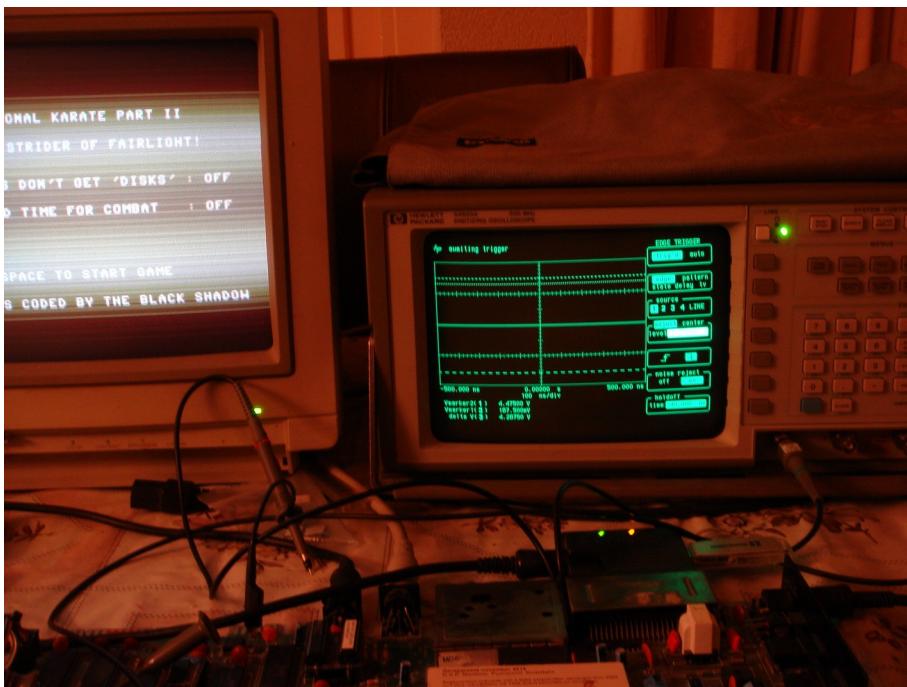
And this means that I am no longer able to get any I/O glitch in situations where I got them before:
